Project report on Parkwohnanlage Nürnberg Bernadottestraße 42 - 48

Dr. Burkhard Schulze Darup

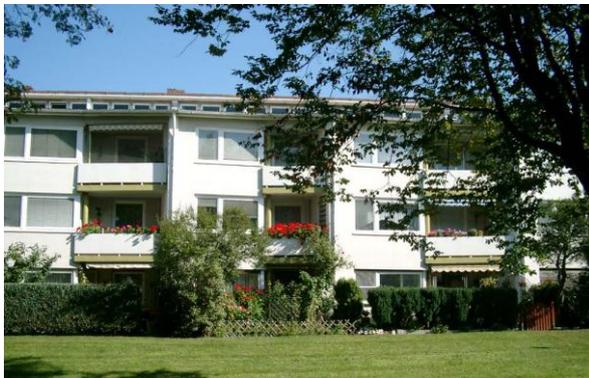
Figure 1: Bernadottestraße 42 - 48 before refurbishment: 24 flats

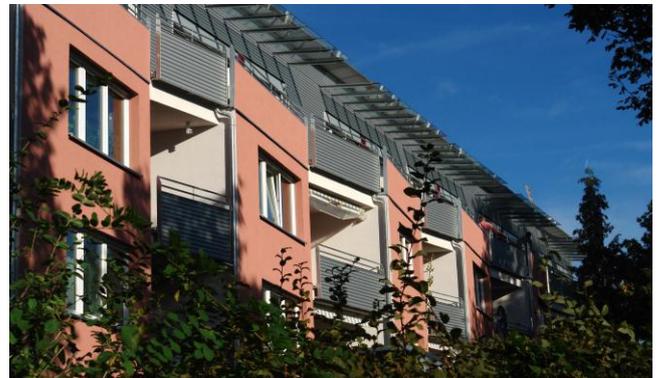
Figure 2: After refurbishment with six additional passive-house flats on the top floor

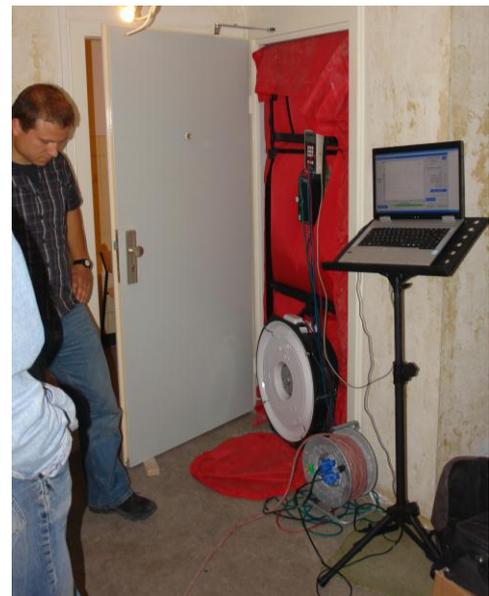
In the existing flats, leakages were found above all in window brackets, empty electrical conduits and electrical boxes and at the entrance doors to the flats. The crucial area however was in the bathrooms, where the old ventilation system with its duct ventilation clearly had more connections to the interior room than the sealed ventilation opening. The newly installed ventilation ducts and heating pipes were very well sealed. Problems however did result in individual places along the ventilation system piping, where individual defects led to leakages.

Figure 3: Blower door test in a flat

In the newly built top floor flats the seals were built from scratch. But even then, increased attention was required at the interfaces between the work of different subcontractors which resulted in much rework. Several blower door tests followed by rework were necessary in order to reach the required n_{50} value $\leq 0.6 \frac{1}{h}$ for each flat under positive pressure.

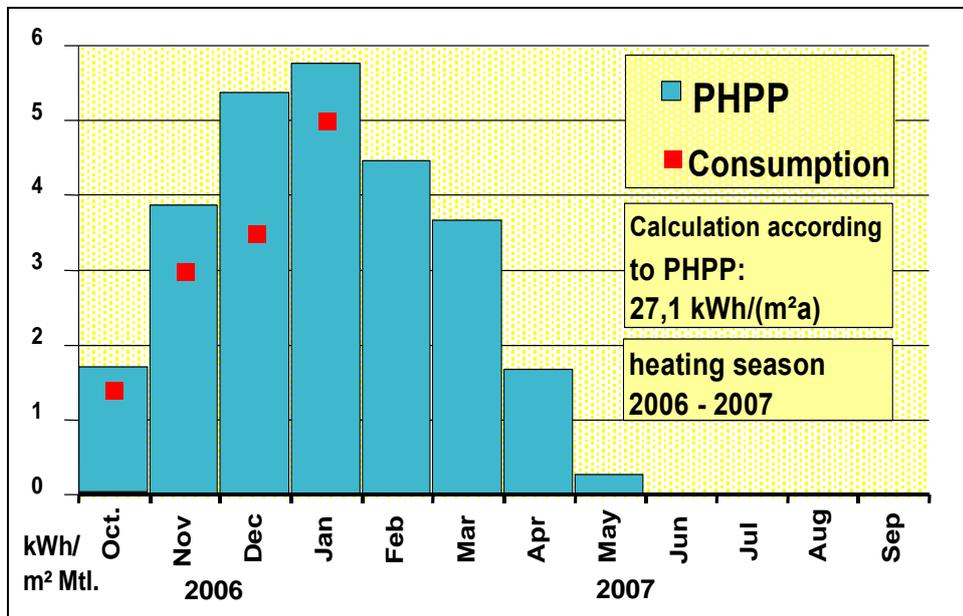
Figure 6: Heat requirement according to PHPP calculation and measured values for the existing flats (as of Feb. 1, 2007)

Consumption is metered monthly at the district heating transfer station. Evaluation of the data (as of Feb.1, 2007, fig. 6) shows that the consumption of heat for heating in existing dwellings lies below the values calculated according to PHPP. A correction by number of heating degree days was, however, not performed.
